**Road Repairs
Merrymount Subdivision**

Culvert Inspection Report

Merrymount Subdivision

April 26, 2026

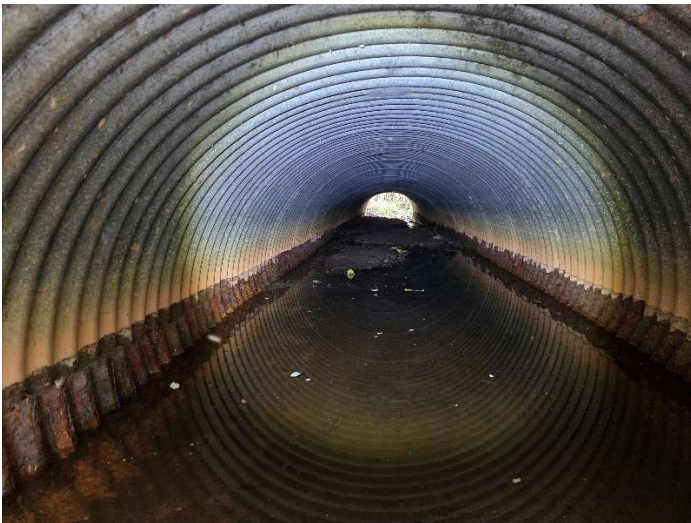
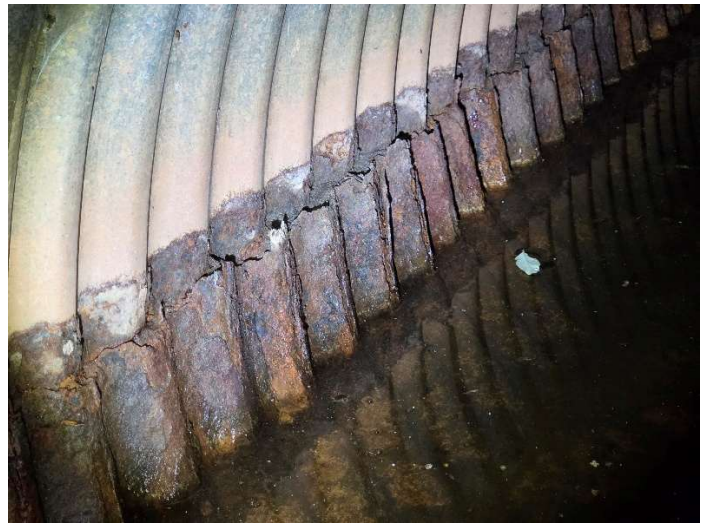
H-1 (first bottom on Hawtree Way) – **Poor Condition - Failure Imminent**

- 42" or 48" Corrugated Metal Pipe
- Live stream with water running thru, could not see bottom to inspect due to water and silt buildup
- Pipe rusted entirely thru in areas along normal water line
- top sunken in about 5" In center of roadway
- 6" and 12" tree growing directly over outlet end

PHASE I	
Description	Cost Estimate
Various asphalt removal & replacements*	\$62,823
Stone along shoulders in various areas	\$4,000
48" Culvert Replacement in first bottom on Hawtree (H-1)	\$45,000
10% Contingencies	\$11,182
Total	\$123,005

- H-1: Imminent failure of 48" culvert due to rusting thru
- H-2: Failure possible in the next 10 years
- H-4: Outfall ditch needs to be graded out to eliminate standing water in culvert
- H-5: Outfall ditch needs to be graded out to eliminate standing water in culvert
- M-1: Minor cleanout at outfall
- M-5: Failure likely in the next 10 years
- M-7: Failure possible in the next 10 years

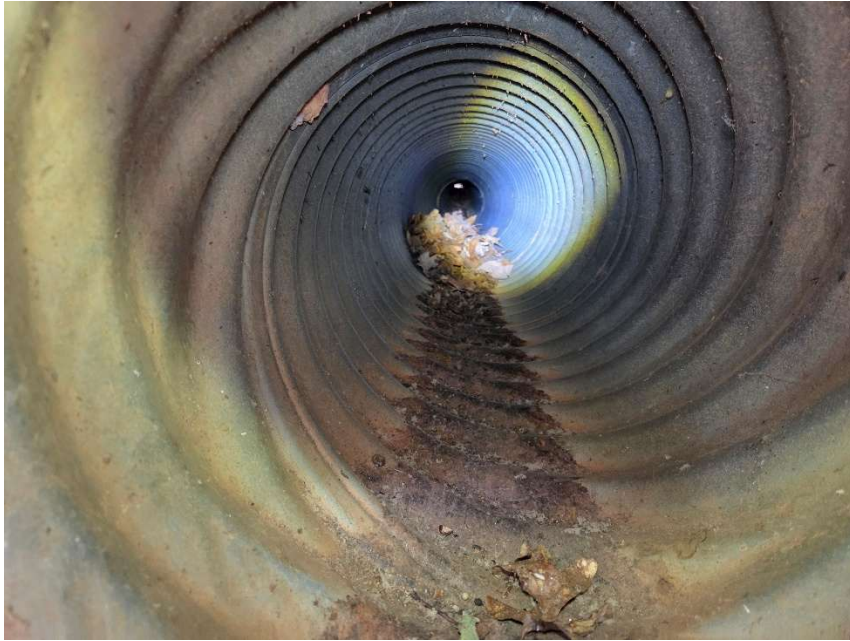
H-3 (Lot 40) – Good Condition

- 15” Corrugated Metal Pipe
- Some rust in bottom but otherwise good condition, no issues

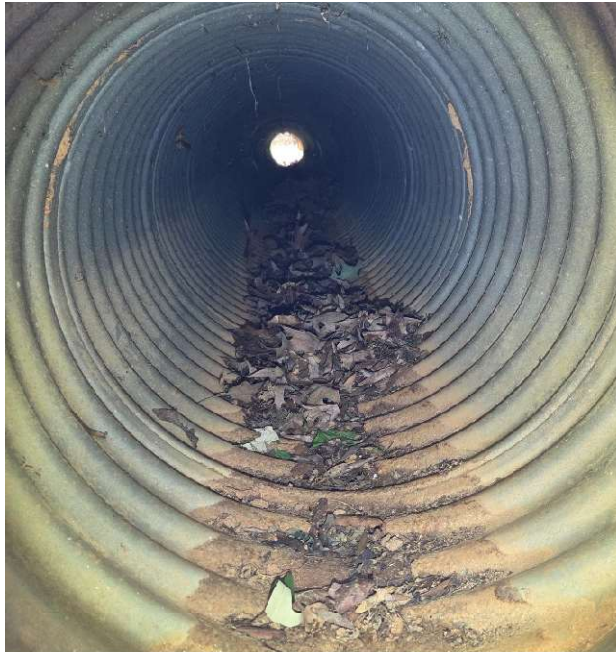
M-3 (Lot 78) – Good Condition

- 24” Corrugated Metal Pipe
- Some rust in bottom but otherwise good condition, no issues
