MERRYMOUNT PROPERTY OWNERS' ASSOCIATION

Culvert Inspection Report

Merrymount Subdivision

April 26, 2026

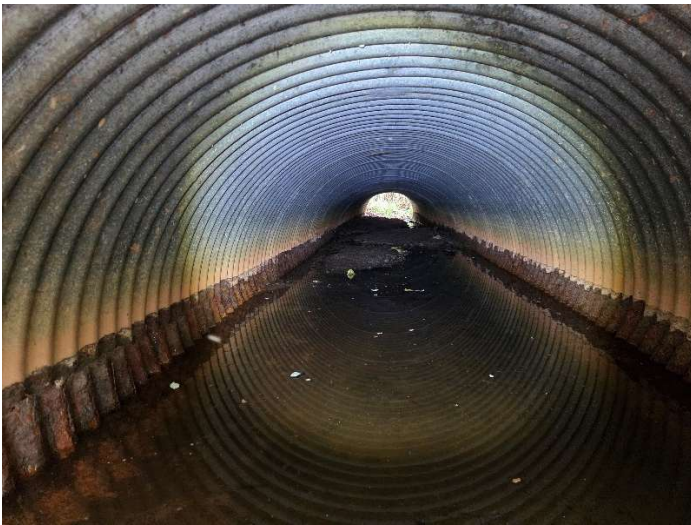
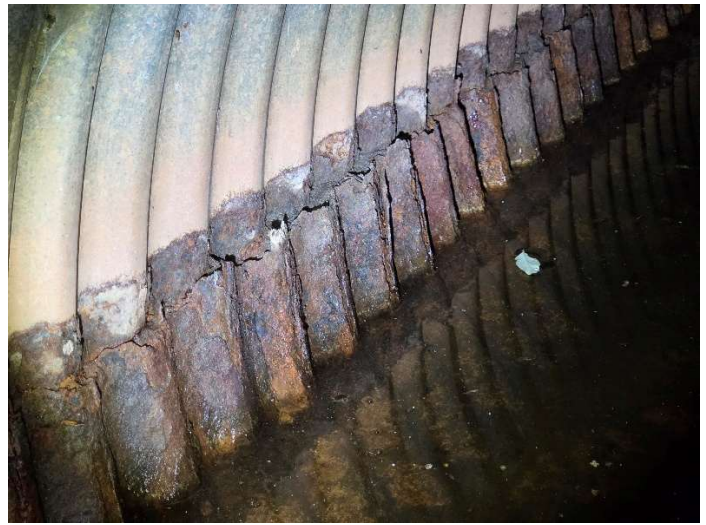
H-1 (first bottom on Hawtree Way) – **Poor Condition - Failure Imminent**

- 42" or 48" Corrugated Metal Pipe
- Live stream with water running thru, could not see bottom to inspect due to water and silt buildup
- Pipe rusted entirely thru in areas along normal water line
- top sunken in about 5" In center of roadway
- 6" and 12" tree growing directly over outlet end

PHASE I	
Description	Cost Estimate
Various asphalt removal & replacements*	\$62,823
Stone along shoulders in various areas	\$4,000
48" Culvert Replacement in first bottom on Hawtree (H-1)	\$45,000
10% Contingencies	\$11,182
Total	\$123,005

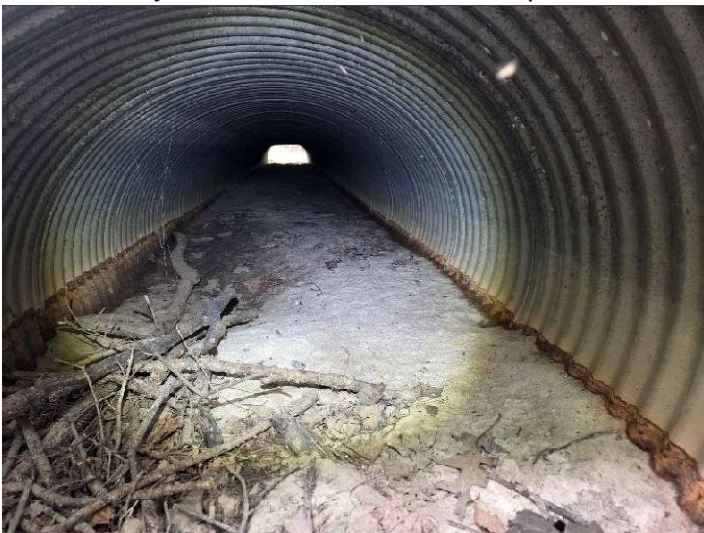
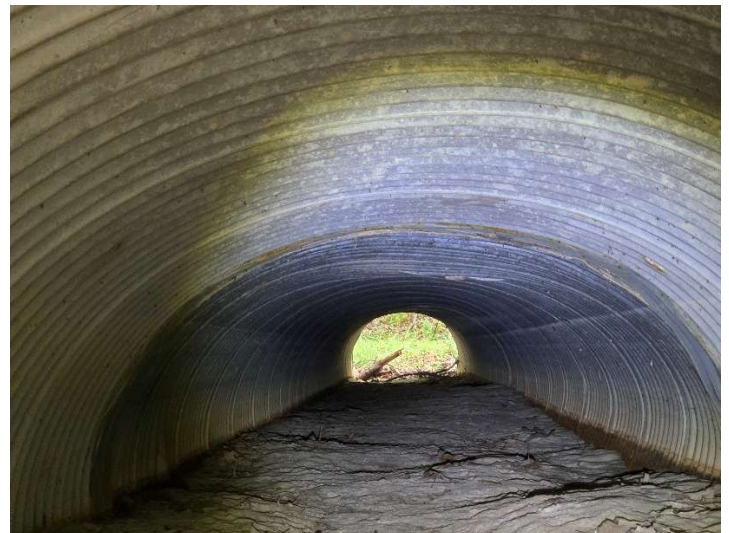
H-2 (2nd bottom on Hawtree Way, at pavilion) – **Poor-Fair Condition**

- **Failure possible in the next 10years, monitor annually**
- 42" or 48" Corrugated Metal Pipe
- Live stream but no water at time of inspection, could not see bottom to inspect due to silt buildup
- rusting along bottom but not severe yet
- top sunken in about 4" in center of roadway
- last joint towards outlet end is questionable

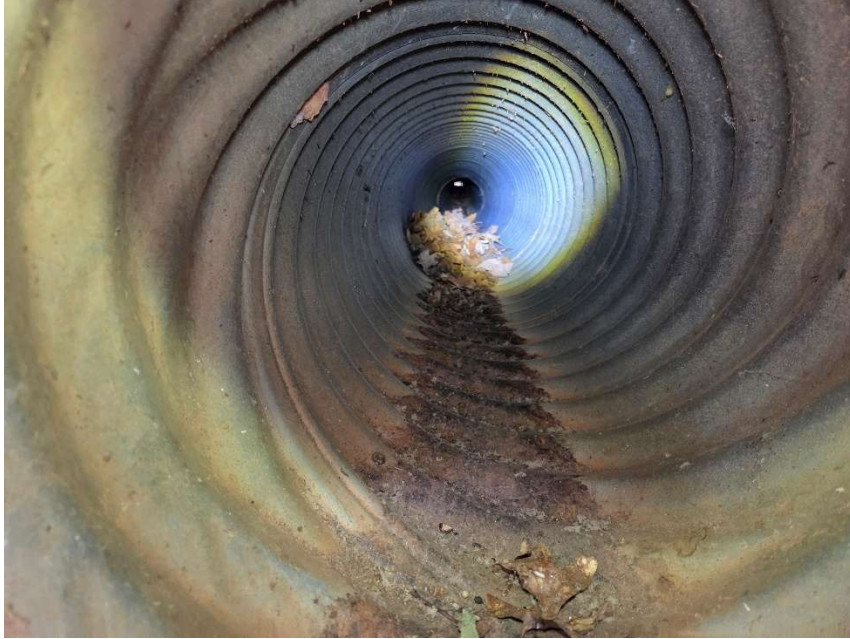
H-3 (Lot 40) – Good Condition

- 15” Corrugated Metal Pipe
- Some rust in bottom but otherwise good condition, no issues

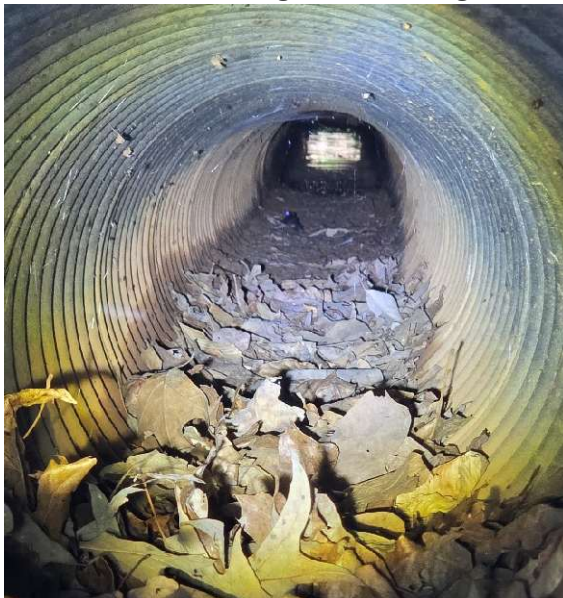
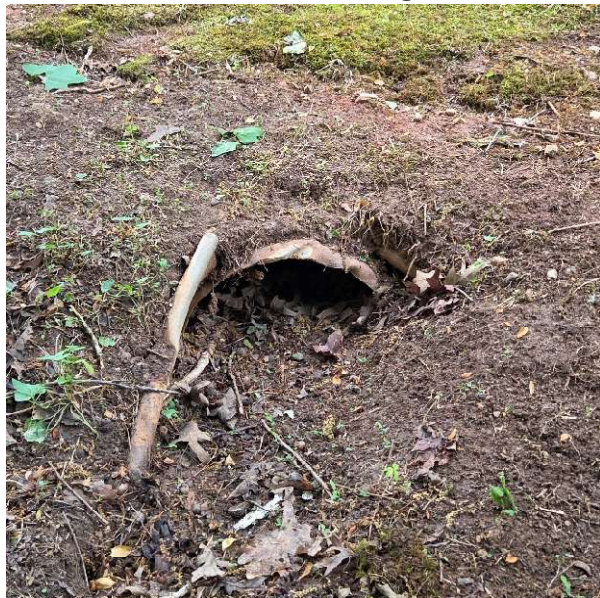
H-4 (Lot 41) – Fair Condition but needs outfall ditch grading

- 15” Corrugated Metal Pipe
- Bottom silted up, could not inspect
- Outlet end is below grade, holding water back. Outlet ditch needs to be graded out to drain

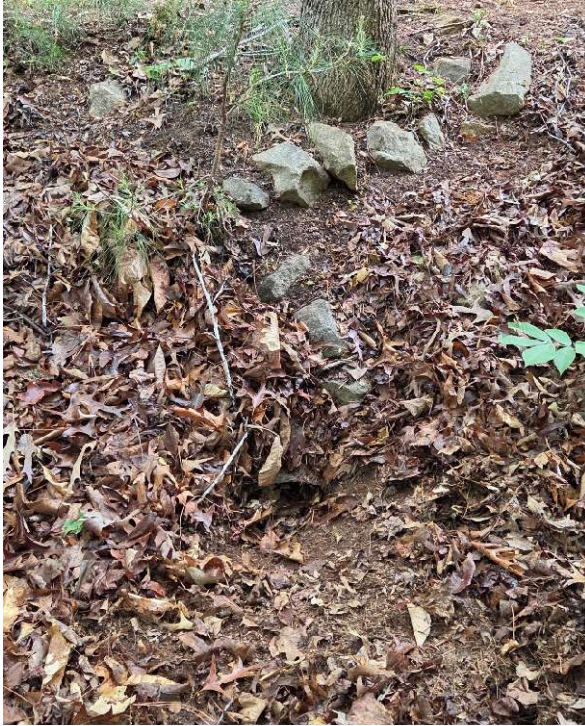
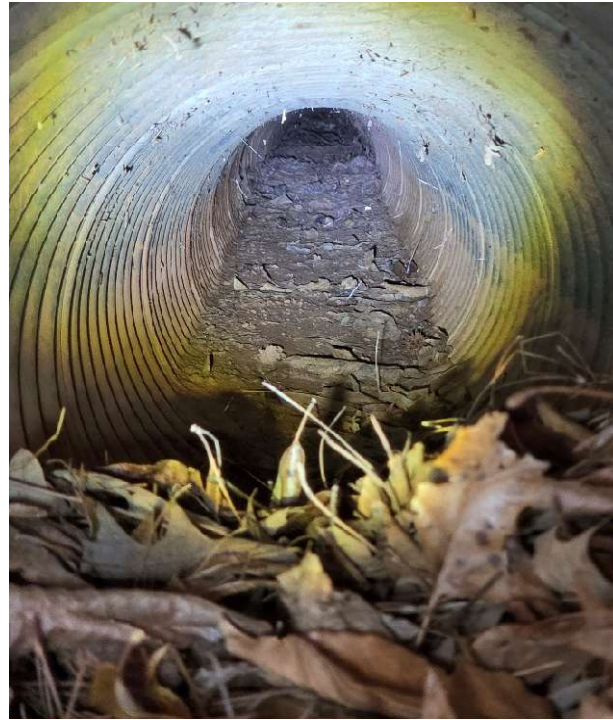
H-5 (Lot 47) – Fair Condition but needs outfall ditch grading

- 15" Corrugated Metal Pipe
- Bottom silted up, could not inspect
- Outlet end is below grade, holding water back. Outlet ditch needs to be graded out to drain
- Outlet end has 12" tree growing overtop that should be removed

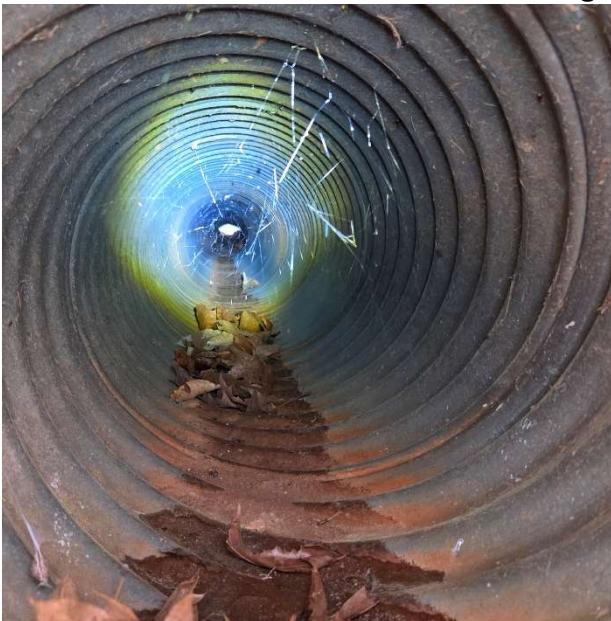
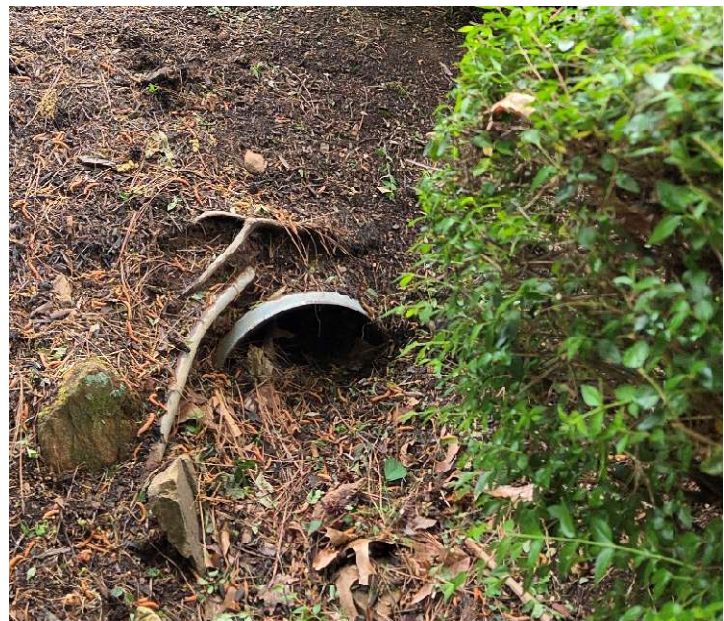
M-1 (Lot 54) – Good Condition but needs minor clean out of outfall ditch

- 15" Corrugated Metal Pipe
- Some rust in bottom but otherwise good condition, no issues

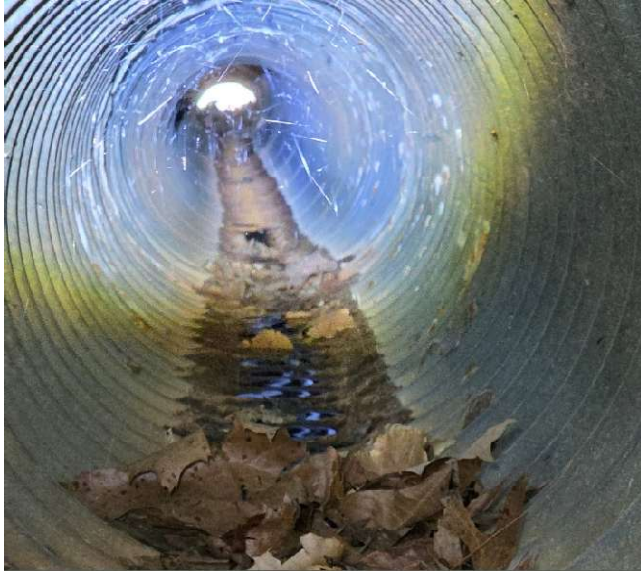
M-2 (Lot 73) – Good Condition

- 15” Corrugated Metal Pipe
- Some rust in bottom but otherwise good condition, no issues

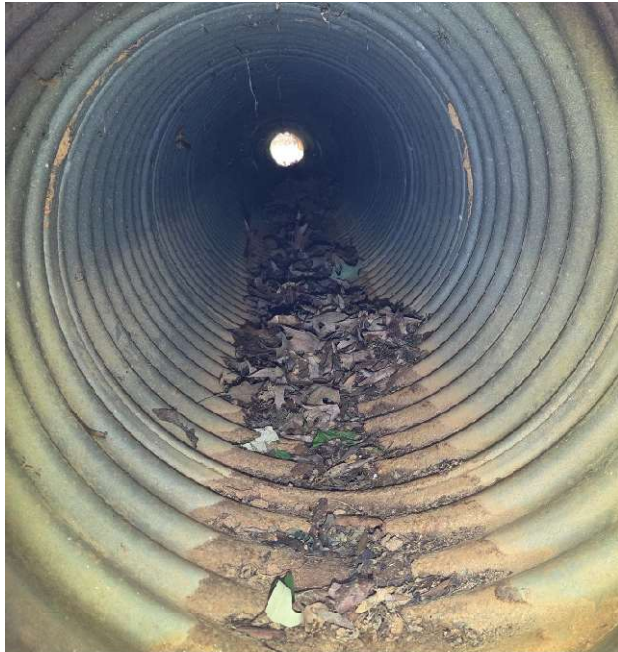
M-3 (Lot 78) – Good Condition

- 24” Corrugated Metal Pipe
- Some rust in bottom but otherwise good condition, no issues

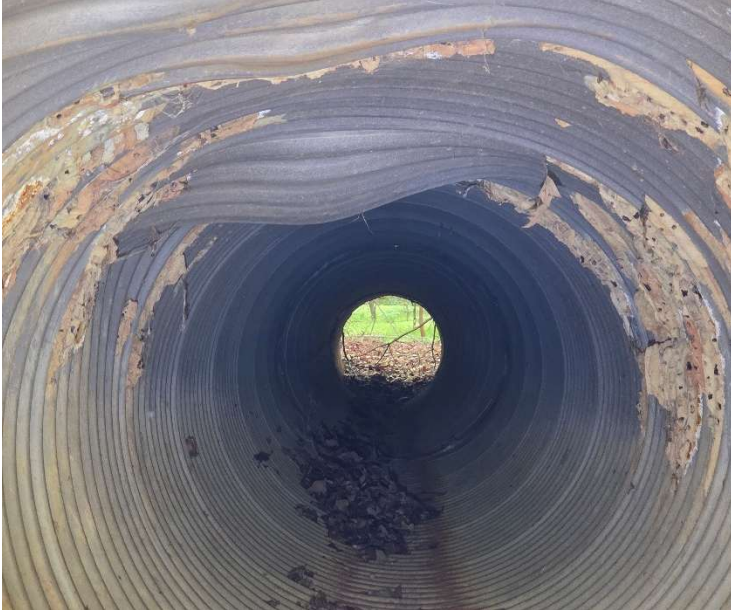
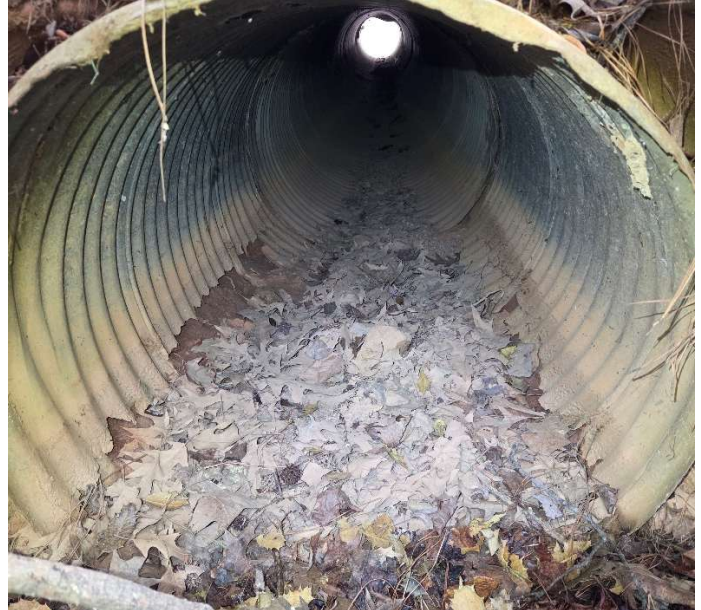
M-4 (Lot 85) – Fair Condition

- 36" Corrugated Metal Pipe
- Mostly good condition with exceptions
- Small area about 8ft from inlet is crushed in about 6" likely due to heavy load parked on shoulder (this is not under roadway) is not an issue
- Last 10ft section of pipe has bottom rusted out but is not under roadway, no improvements recommended though

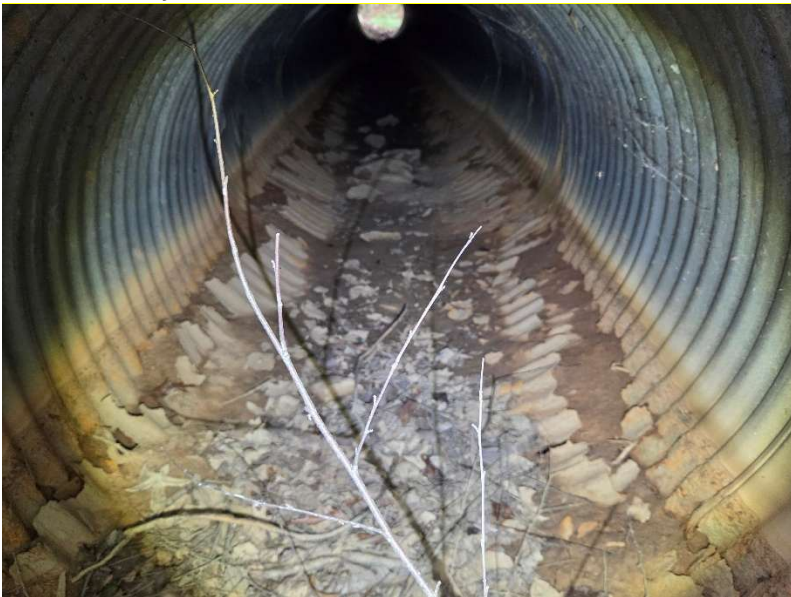
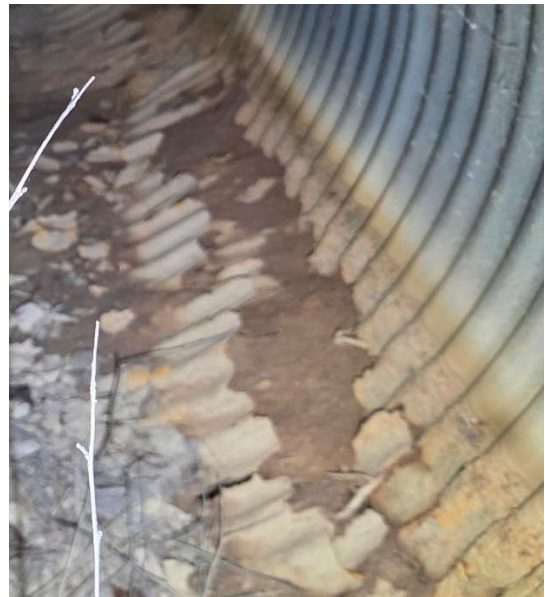
M-5 (Lot 93) – Poor Condition

- Failure likely in the next 10years, monitor annually
- 48" Corrugated Metal Pipe
- Bottom rusted all the way out
- Last joint has issues

PHASE III	
Description	Cost Estimate
Fully rebuild stone & asphalt 420ft of west end of Merrymount	\$109,200
Asphalt removal & replacement 340ft of west end of Merrymount	\$40,800
Chip & Seal 980ft of west end of Merrymount	\$18,000
48" Culvert Replacement last bottom on west end Merrymount (M-7)	\$40,000
48" Culvert Replacement third bottom from west end Merrymount (M-5)	\$40,000
10% Contingencies	\$24,800
Total	\$272,800

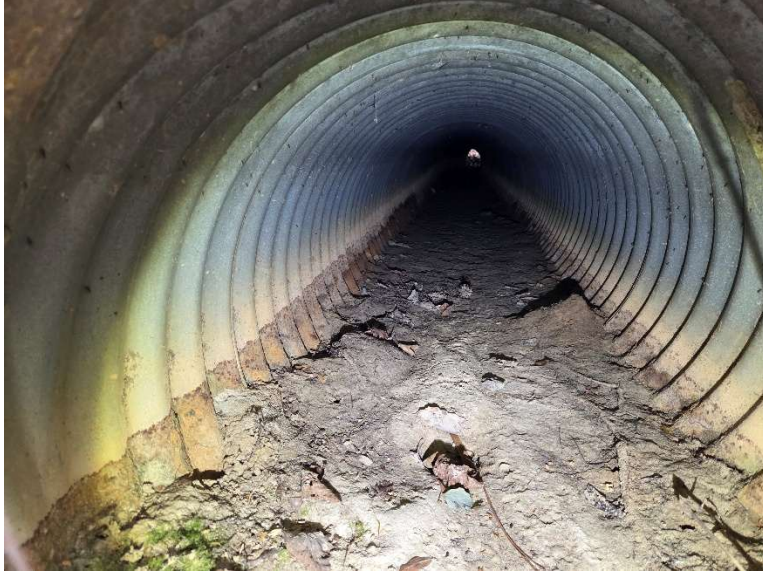
M-6 (Lot 96) – Fair Condition

- 24” Corrugated Metal Pipe
- Rusting along bottom but not severe yet, otherwise good condition
- Bottom silted up, could not inspect

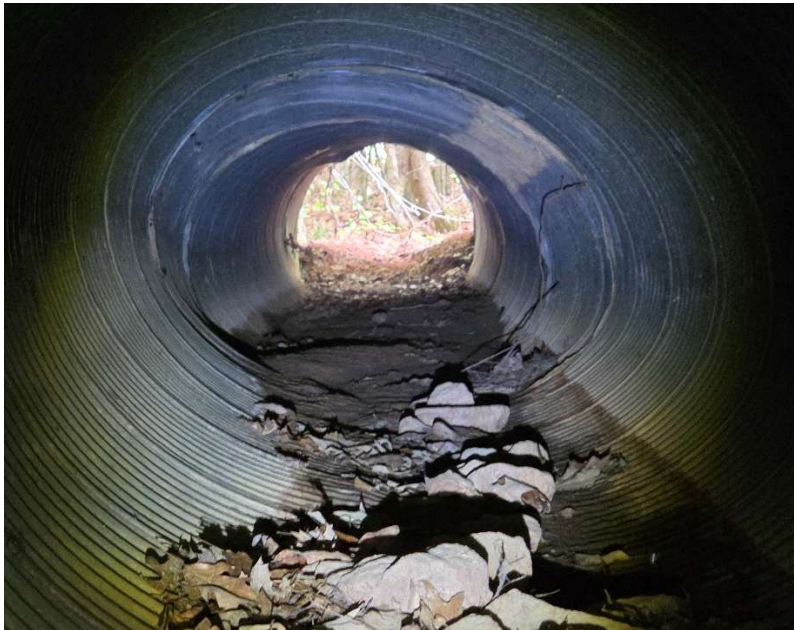
M-7 (Lot 97) – Poor-Fair Condition

- Failure possible in the next 10years, monitor annually
- 48” Corrugated Metal Pipe
- Pipe deformed about 8" in various spots under roadway
- Rusting along bottom but not severe yet
- Bottom has some silt, could not fully inspect

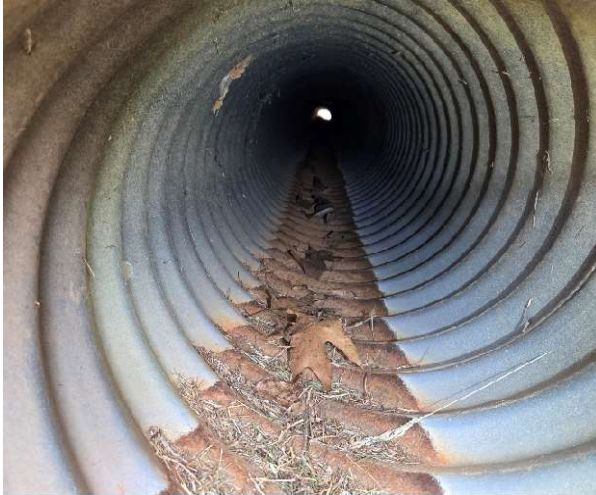
BA-1 (Lot 5) – Good Condition

- 15” Corrugated Metal Pipe
- Some rust in bottom but otherwise good condition, no issues

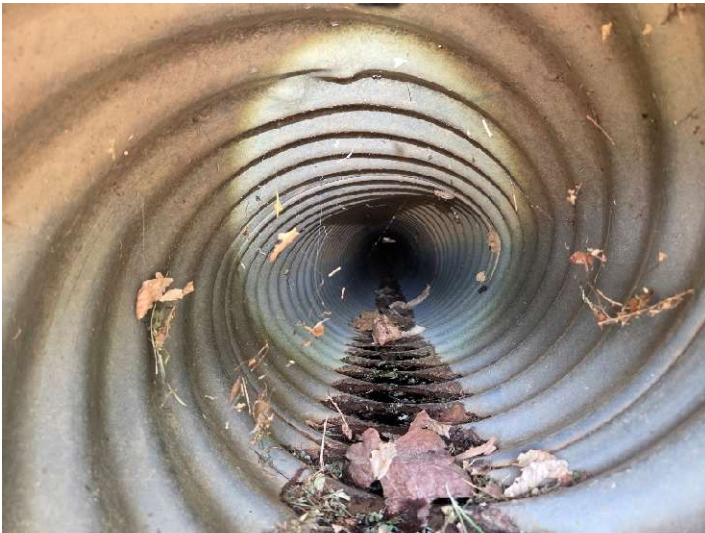
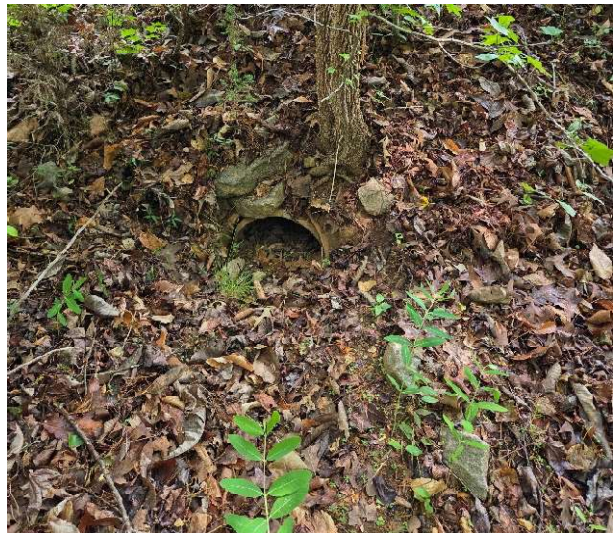
B-1 (Lot 30) – Good Condition

- 15” Corrugated Metal Pipe
- Outlet end is below grade, holding water back. Outlet ditch needs to be graded out to drain, but not likely possible as it's very flat and several trees would have to be removed.

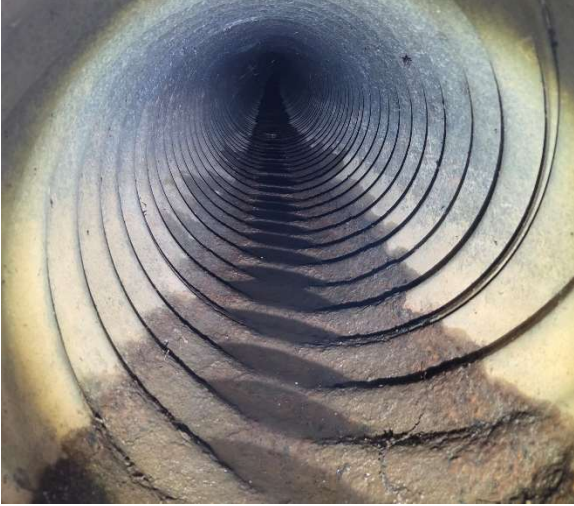
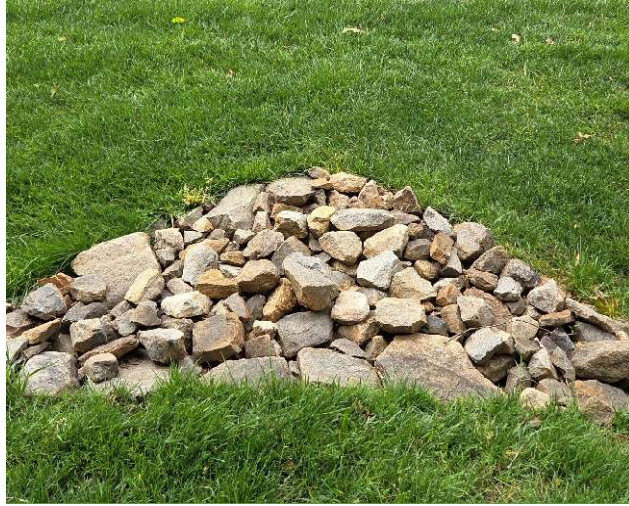
B-2 (Lot 27) – Good Condition

- 15” Corrugated Metal Pipe
- Inlet end covered with decorative stone, could not inspect
- From outlet end, some rust in bottom but otherwise good condition, no issues

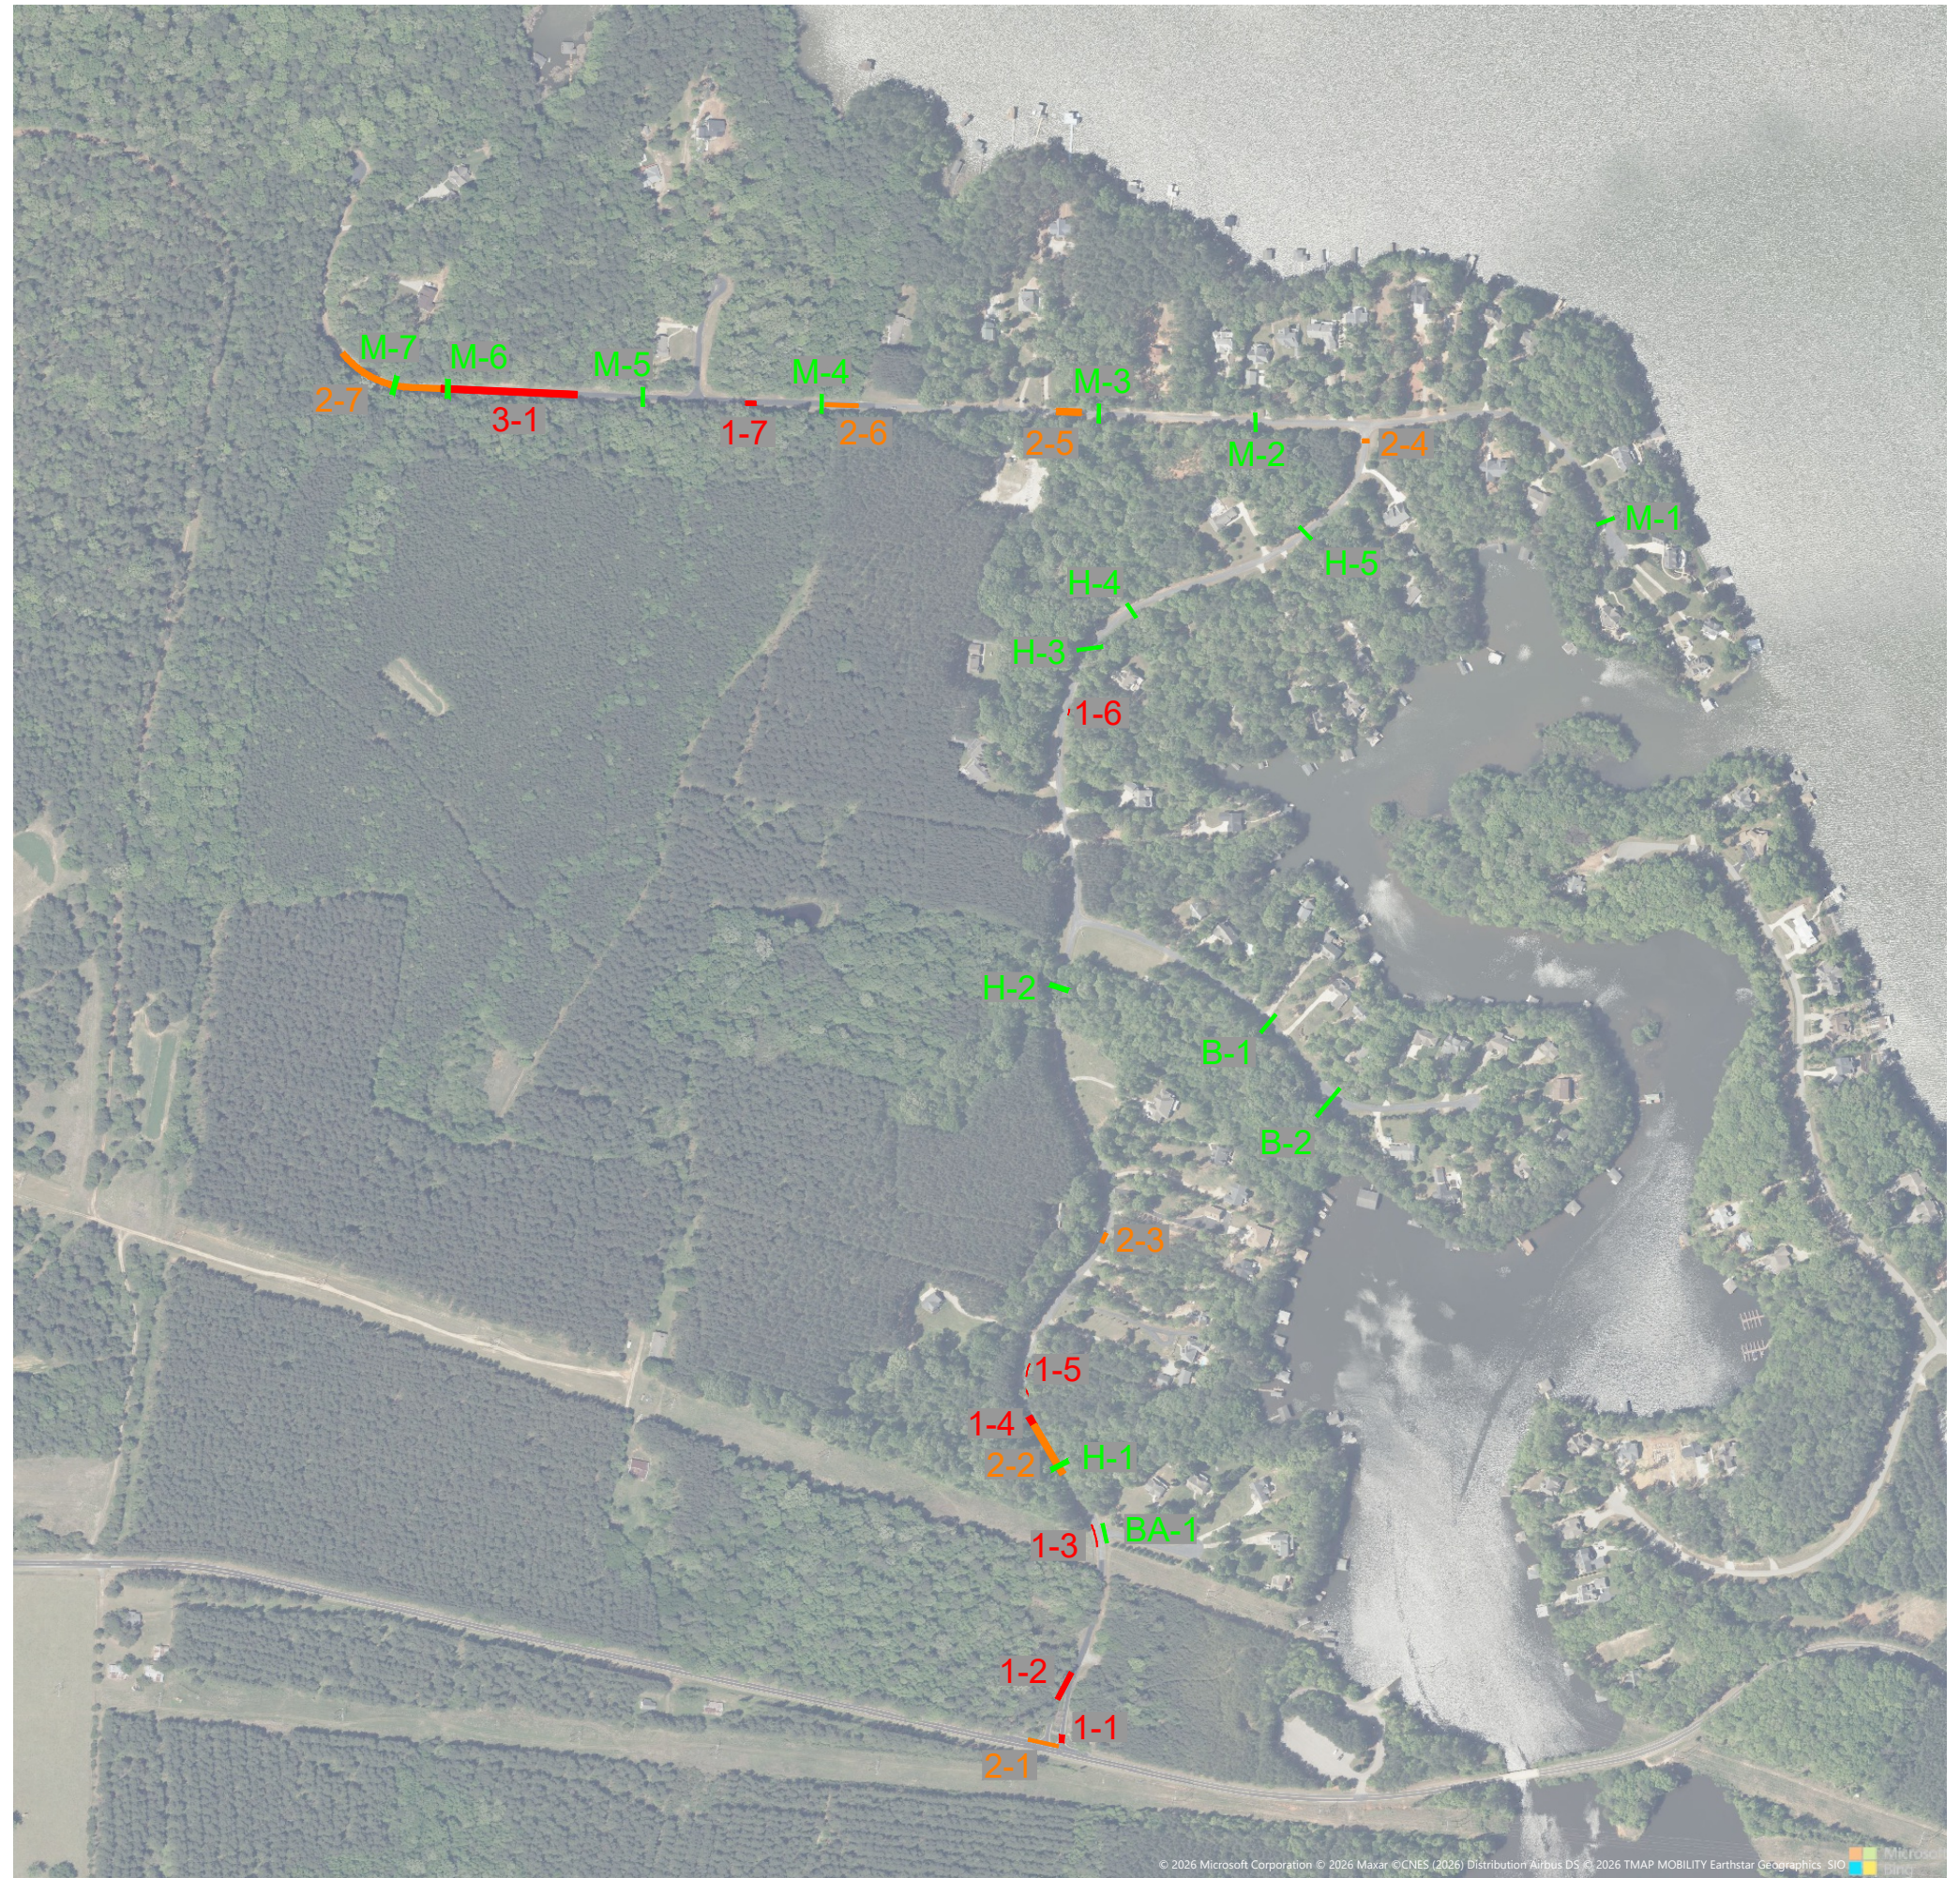
Culverts requiring work

- H-1: Imminent failure of 48" culvert due to rusting thru
- H-2: Failure possible in the next 10 years
- H-4: Outfall ditch needs to be graded out to eliminate standing water in culvert
- H-5: Outfall ditch needs to be graded out to eliminate standing water in culvert
- M-1: Minor cleanout at outfall
- M-5: Failure likely in the next 10 years
- M-7: Failure possible in the next 10 years

1. Recommend remove & replace with asphalt

- 1-1: 24'x16' replacement in northbound lane
- 1-2: 90'x13' replacement in southbound lane
- 1-3: 70'x1.5' along road edge
- 1-4: 30'x18' full width
- 1-5: 45'x1.5' along road edge
- 1-6: 18'x1.5' along road edge

2. Optional remove & replace asphalt

- 2-1: 95'x10'
- 2-2: 175'x18' full width
- 2-3: 30'x9'
- 2-4: 10'x18' full width
- 2-5: 75'x18' full width
- 2-6: 100'x9' eastbound lane
- 2-7: 30'-11' eastbound lane
- 2-8:

3. Remove asphalt, rebuild sub-base, replace stone & 2" asphalt

- 3-1: 350'x18' full width
